PROPERTY INSPECTION REPORT

Concerning: Sample House Built in the '80s Insp.#: 150129- A
(Address or Other Identification of Inspected Property)

By: Danny Pitts, TREC License # 4717 1/29/15
(Name and License Number of Inspector) (Date)

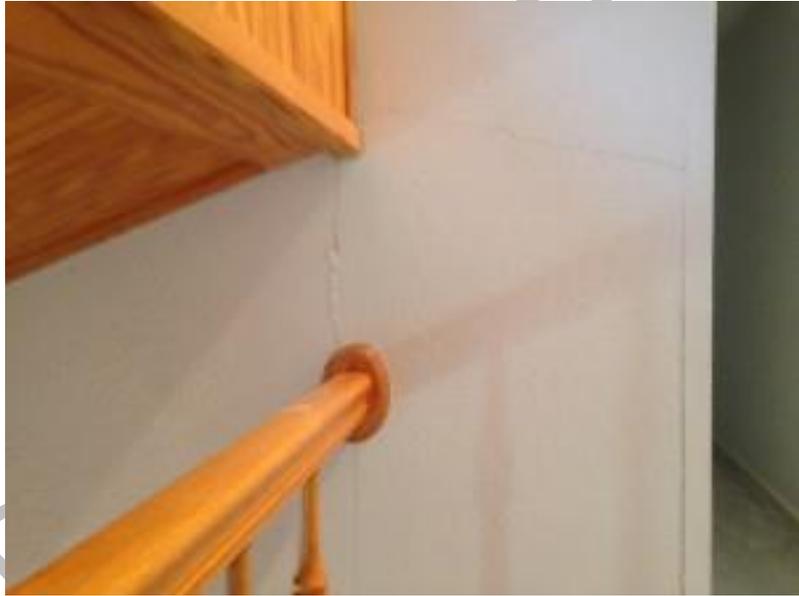
- THE CONCRETE SKIM COATING / PARGE COATING - Is broken / cracked at various locations. The coating is a cosmetic application & does not affect the performance of the slab.
- THE SLAB FOUNDATION HAS A POSSIBLE CRACK – At the hall bath.
- THERE IS A DIAGONAL SHEETROCK PRESENT – At the upstairs hall.

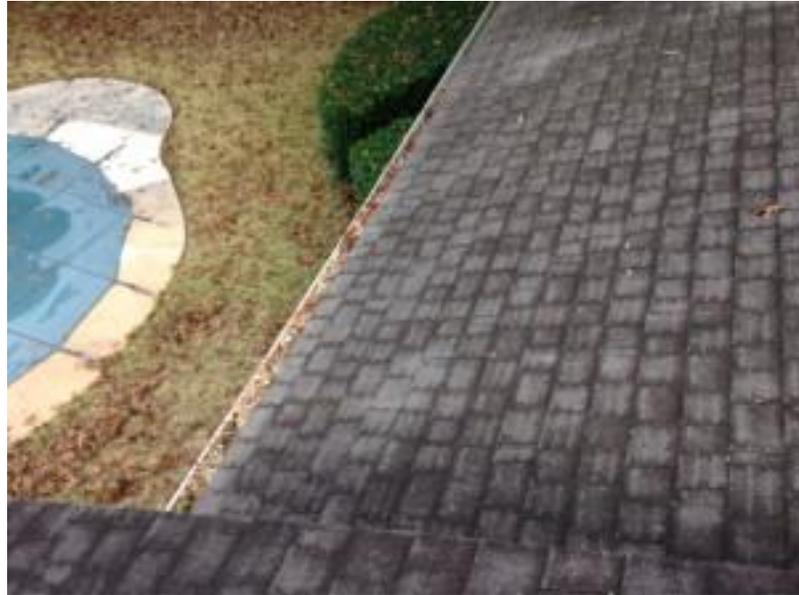
- THE GUTTERS – Remove all debris from the gutters.

- REGRADE THE SOIL – Regrade the soil down & away from the foundation (the code requires 5% slope extending 10 ft. out from the house) to divert the water around & away from the house. In other words, this means that the soil should fall 6 in. within 10 ft. of the house on all 4 sides of the house.

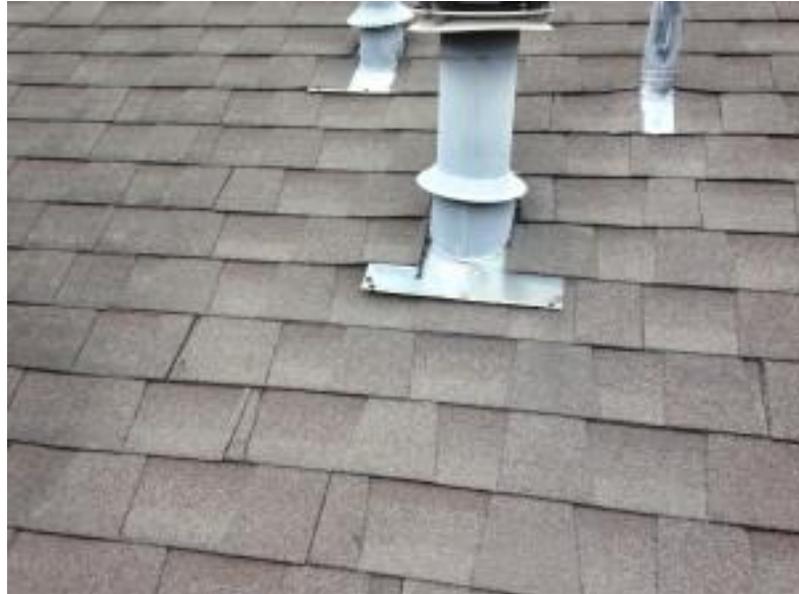
- THE VENT PIPE FLASHING BOOTS - Are loose at various locations, re nail.

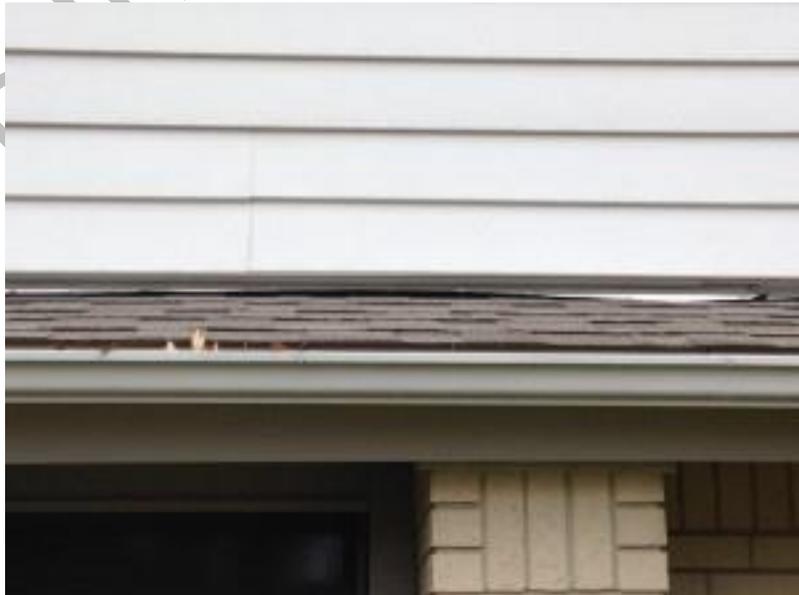
- LOOSE FLASHINGS – At various locations including at the right front.

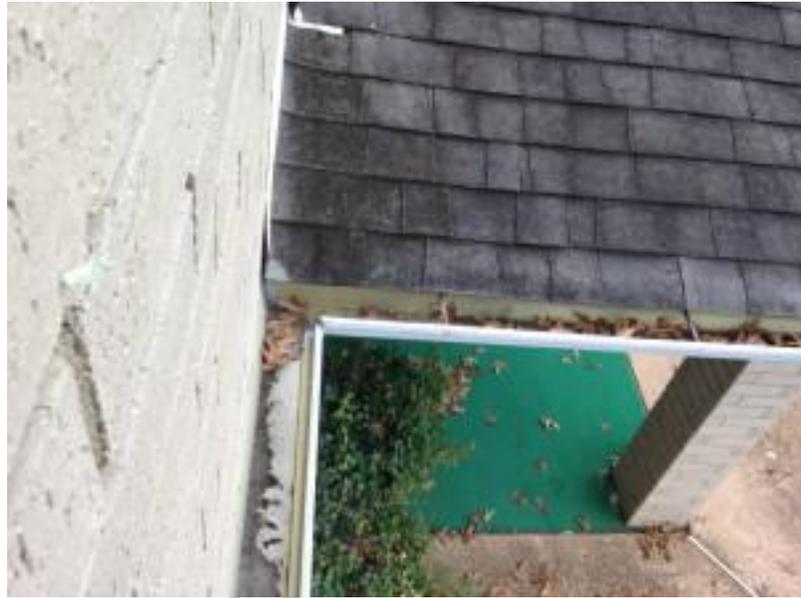
- CAULK THE COUNTER FLASHINGS / FLASHING ENDS – At the roof / wall connections at various locations including at the chimney to prevent water penetration.

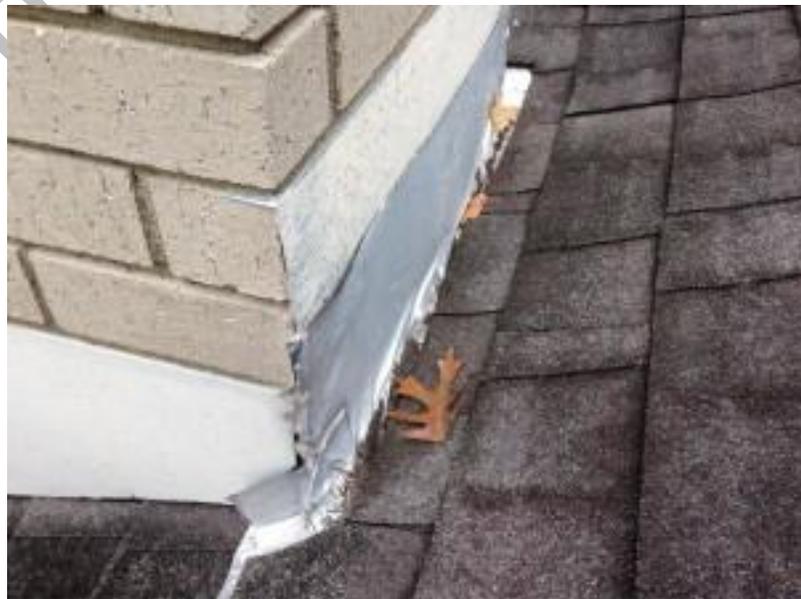
- THE FLASHINGS / COUNTER FLASHINGS HAVE BEEN “REPAIRED” – At the chimney.

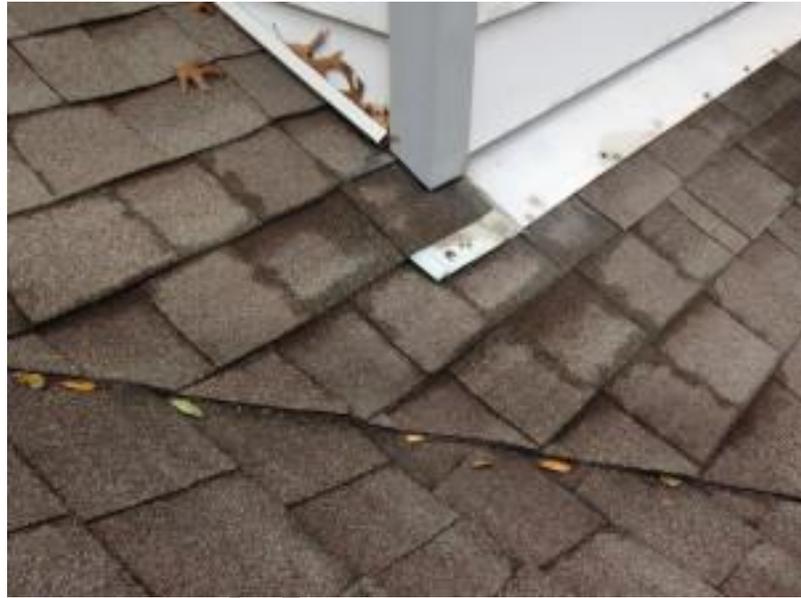
- MISSING STEP FLASHINGS – Step flashings are required at the roof / wall connections by code. NOTE: Turnback flashings / J flashings are present rather than step flashings. The use of turnback flashings is a common construction practice in the Central Texas region.

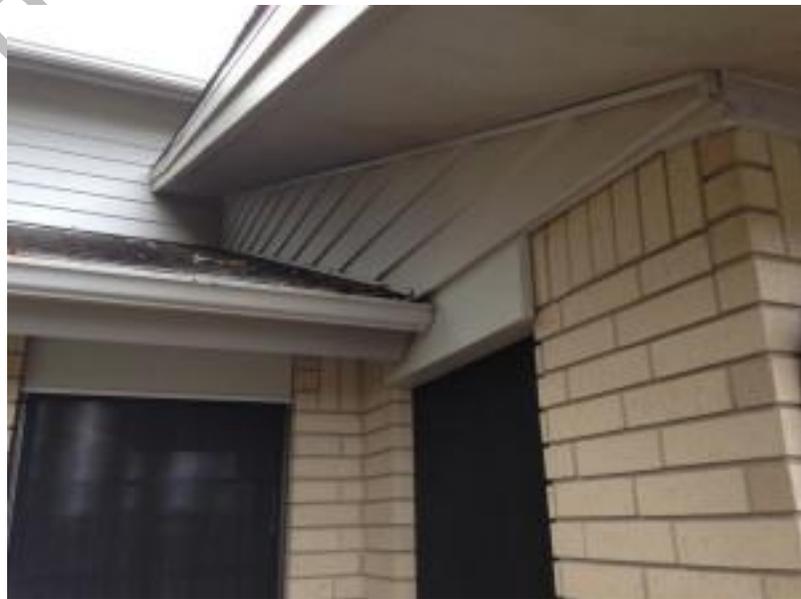
- MISSING FACTORY BUILT KICKOUT FLASHING – At the roof / wall connection at the right rear where a wall extends below the roof termination (to prevent water penetration behind / into the siding).

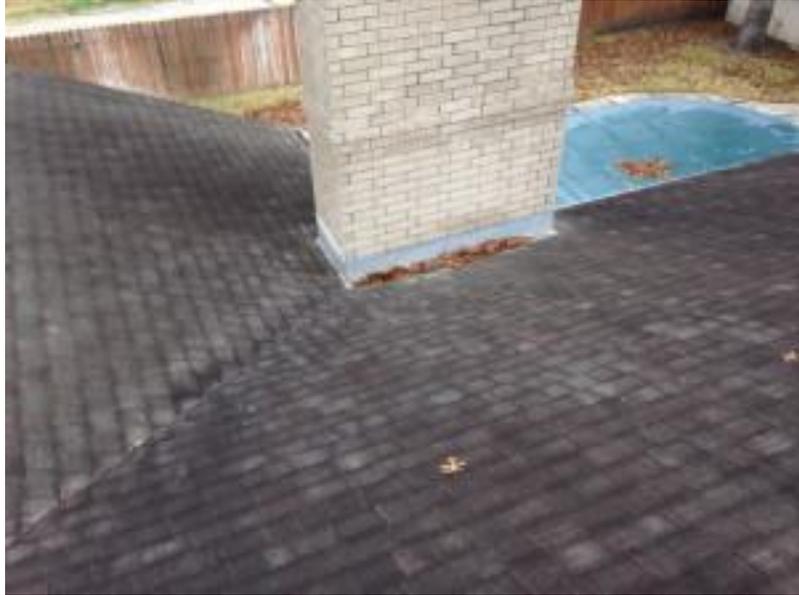
- THERE IS A DEAD VALLEY (THE VALLEY TERMINATES INTO THE SIDE OF A WALL) – At the chimney.

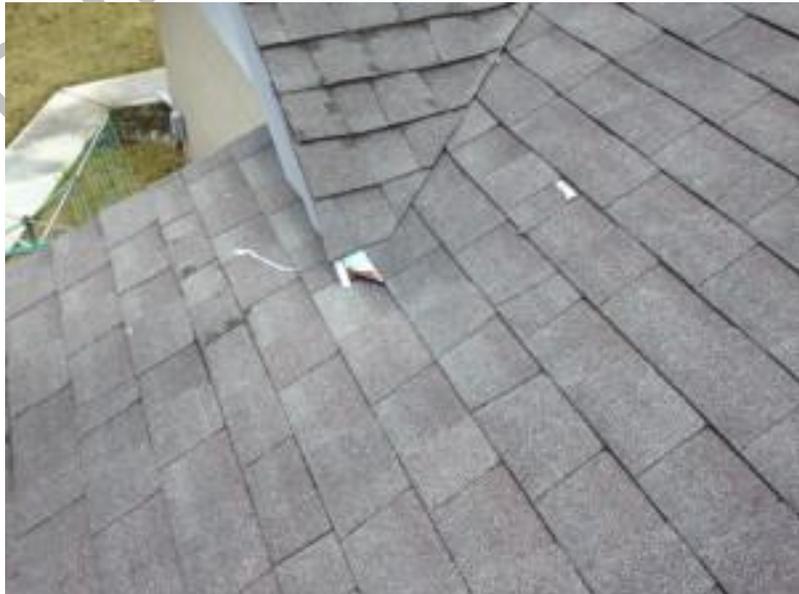
- THE VALLEY FLASHINGS – Are rusting at various locations.

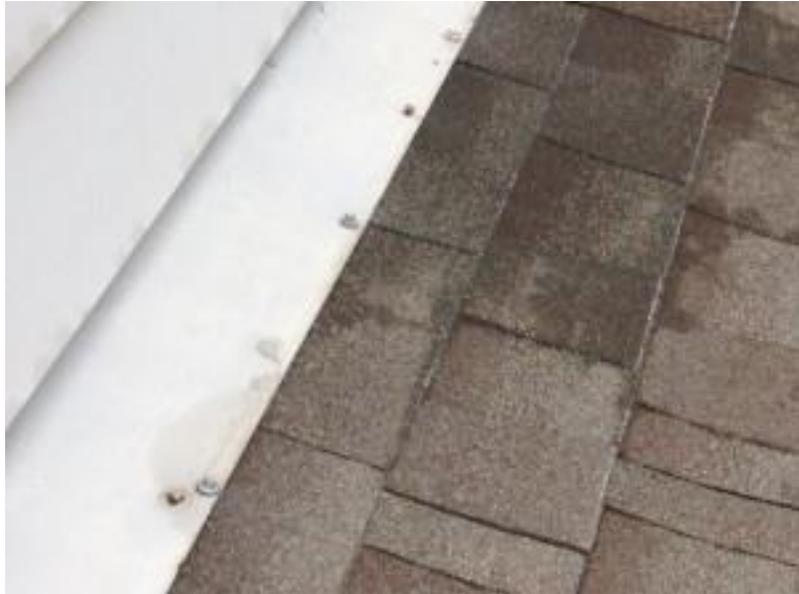
- LOOSE NAILS – At the front roof / wall flashing.

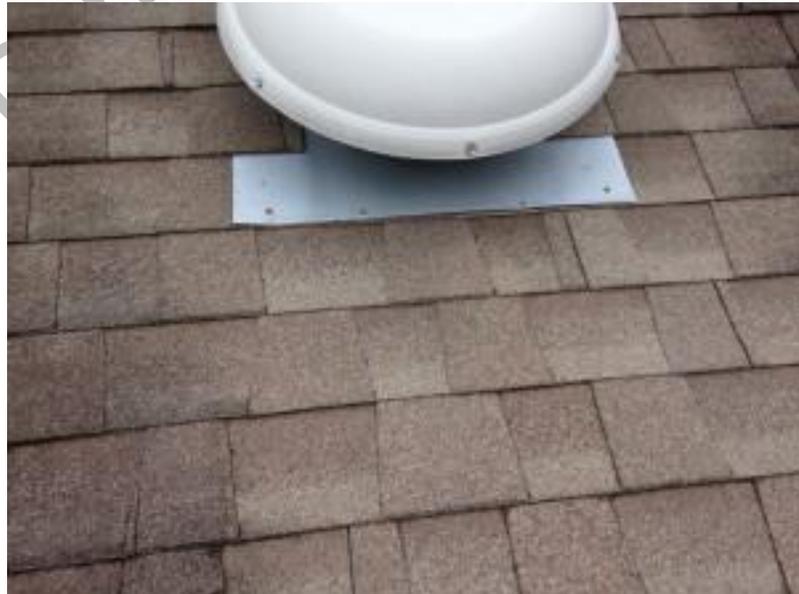
- ALL EXPOSED ROOF NAILS / STAPLES - Are not sealed (caulked) at the flashings, roof vents & ridge shingles to prevent water penetration.

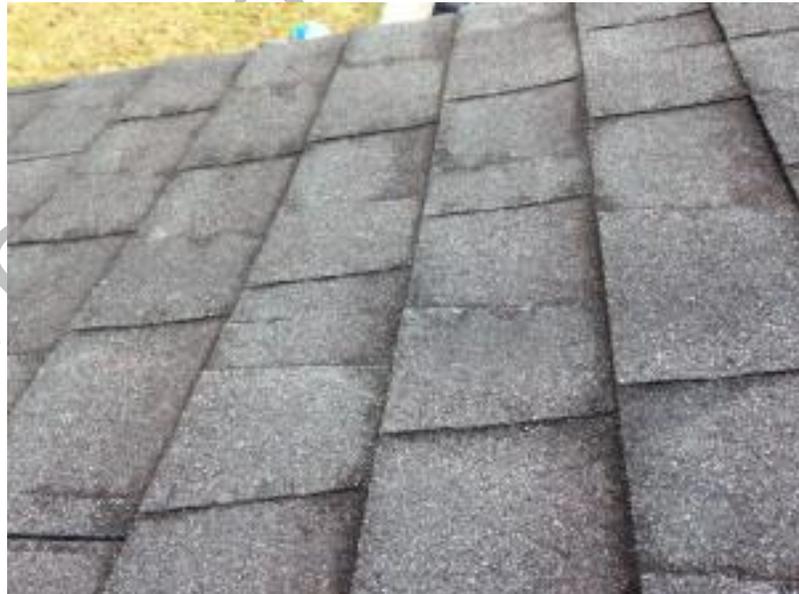
- THE ROOF – Is worn, has very little of its life left.

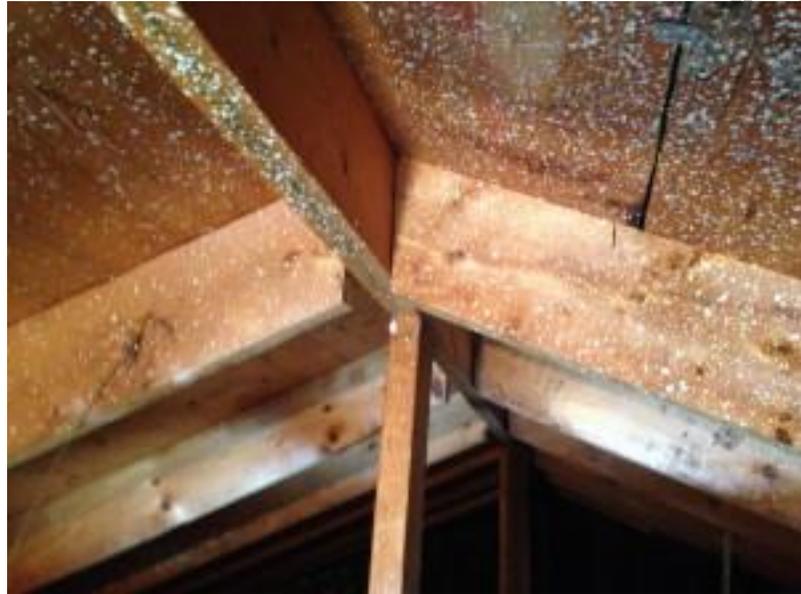
- The ridge board is not 1 dimension size larger (2x8) than the roof rafters (2x6) as required.

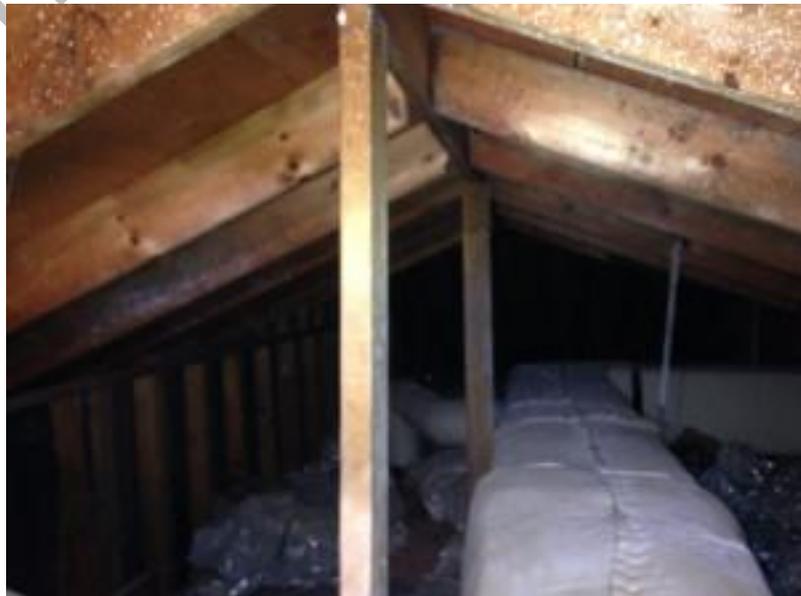
- Collar ties are missing at the ridge every 4 ft. apart above the laundry room & kitchen.

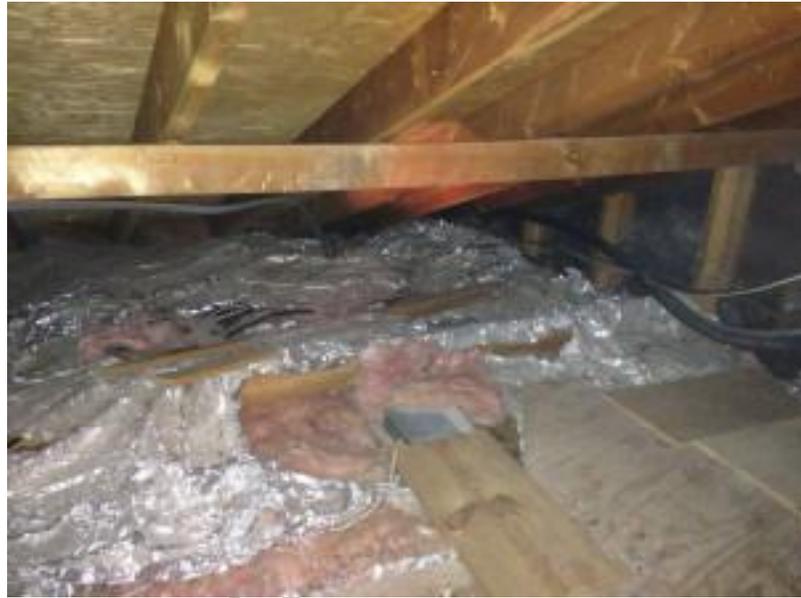
- Purlin bracing is missing at the long rafter spans at the right of the laundry room.
- Purlin bracing is missing downward supports every 4 ft. apart at the left of the laundry room & at the right rear.

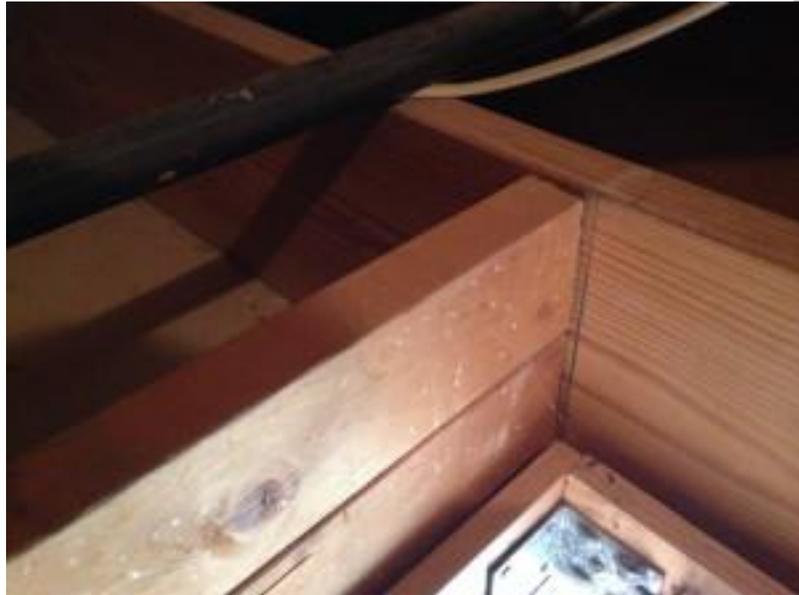
- Loose / poor fitting joints at the hip, valley, & ridge rafters at various locations. Add mechanical connectors to stabilize the loose / poor fitting joints.
- Joist hangers are missing at the headers between the ceiling joists at the attic doors.

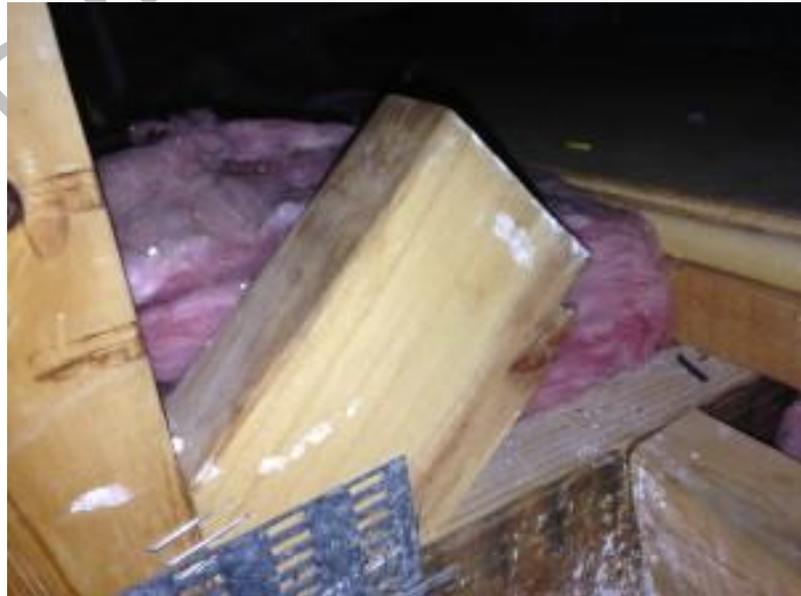
- Four trusses have been cut at the upstairs AC.

- THE ROOF SAGS – At various locations including at the cut trusses.

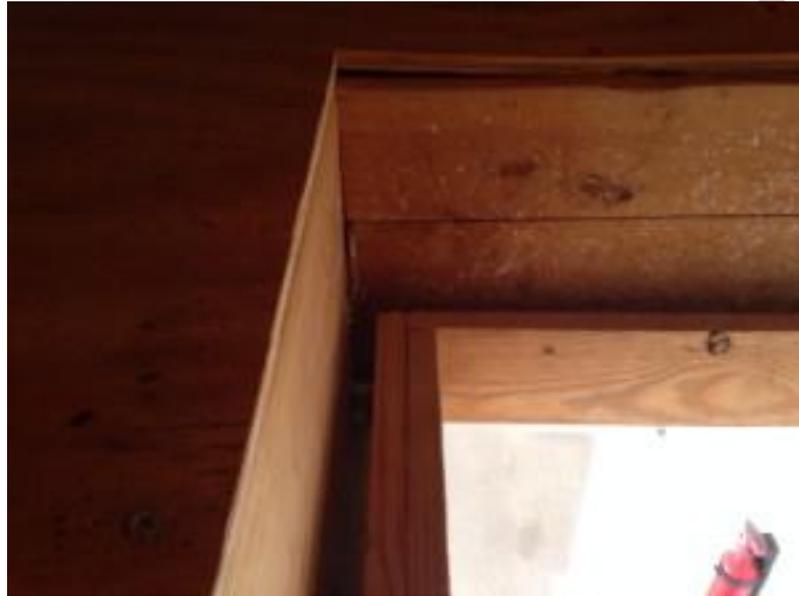
- THE INSULATION - The insulation has poor / uneven coverage at various locations. I would suggest that a minimum of R-38 be added to the ceilings.
- THE ATTIC DOORS (PULL DOWN STAIRS IN THE GARAGE / SHEETROCK UPSTAIRS) – The upstairs door is missing weather stripping & insulation. The garage door frame is not properly blocked / shimmed to the ceiling framing. Secure the frame with 16d nails or ¼ in. x 3 in. lag screws through shims (not sheetrock screws or deck screws).

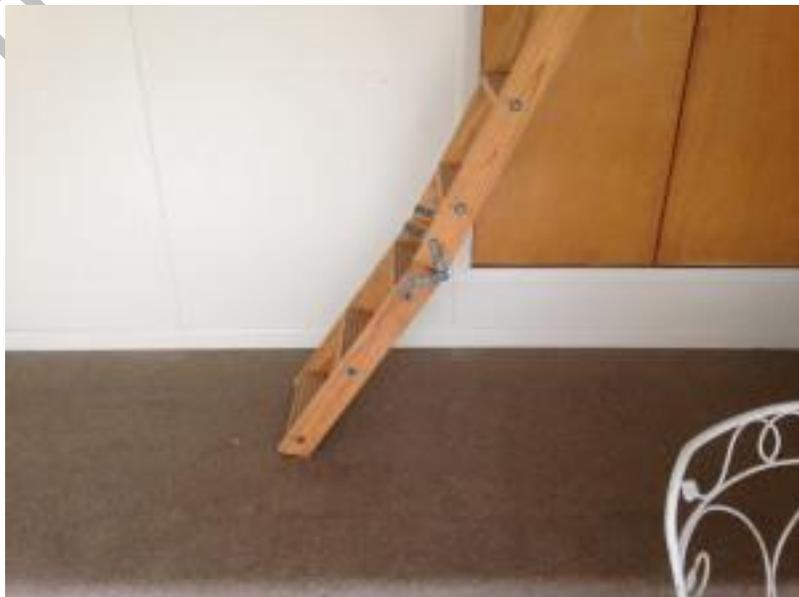
- Cut the legs of the garage stairs so that the stairs are straight & the hinges are properly engaged. The garage attic door is not a fire rated door.

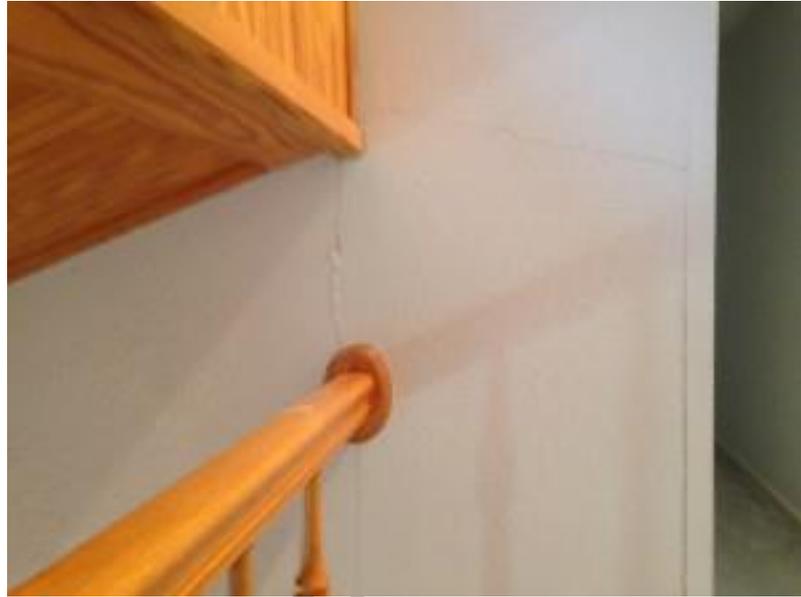
- SHEETROCK SETTLING CRACKS – At various wall locations including at the den & the upstairs hall.

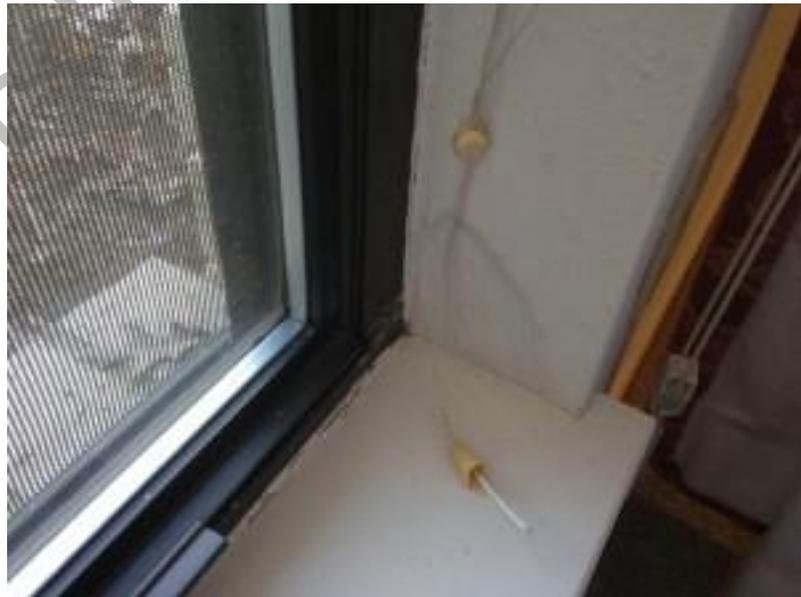
- LOOSE CORNER BEAD – At the upstairs hall.
- WATER STAINS – At various windows.

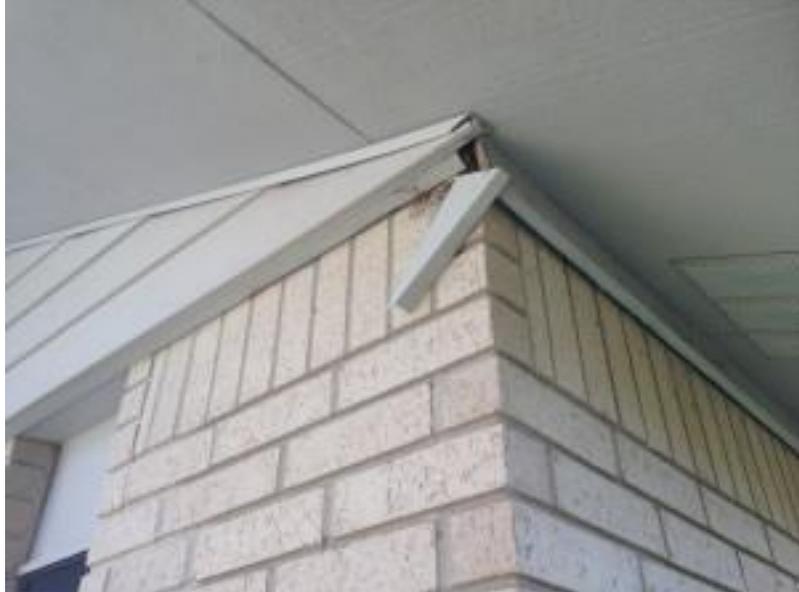
- LOOSE / DAMAGED EXTERIOR TRIM - At the left rear.

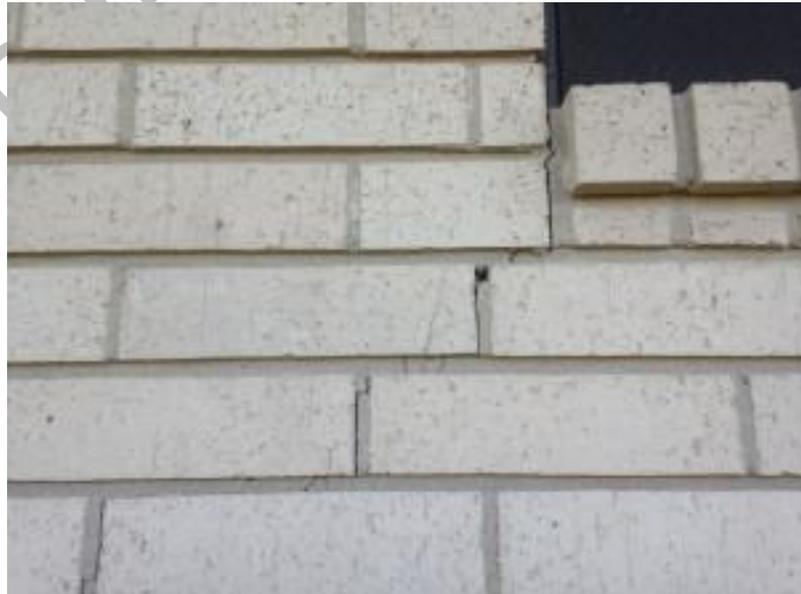
- STAIR STEP CRACKS IN THE BRICK – At the right. Seal the cracks to prevent water penetration.

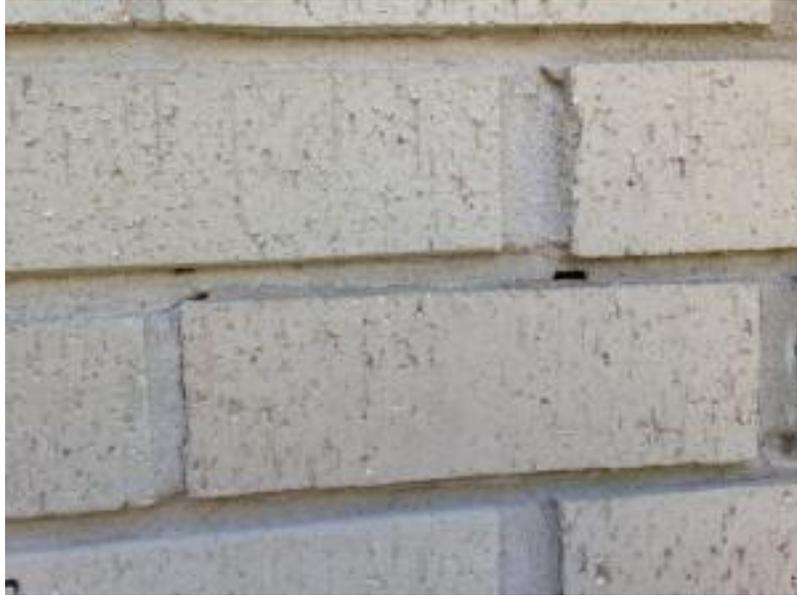
- CRACKS / HOLES IN THE BRICK MORTAR - At various locations. Seal the cracks & holes to prevent water penetration.

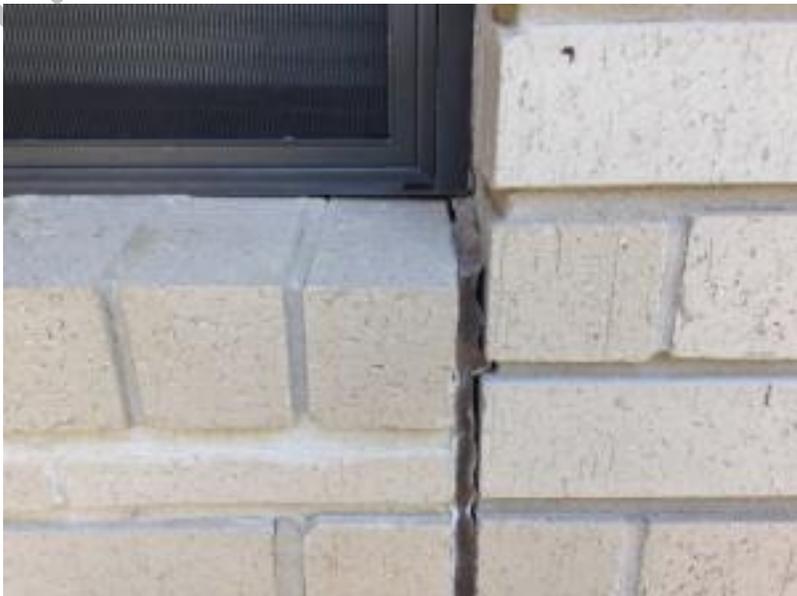
- RECAULK – At the brick moldings, the brick expansion joints, the windows, the trim & the siding connections at various locations (to prevent water penetration). Seal all the wall penetrations. The maintenance of the caulk will be an ongoing process.

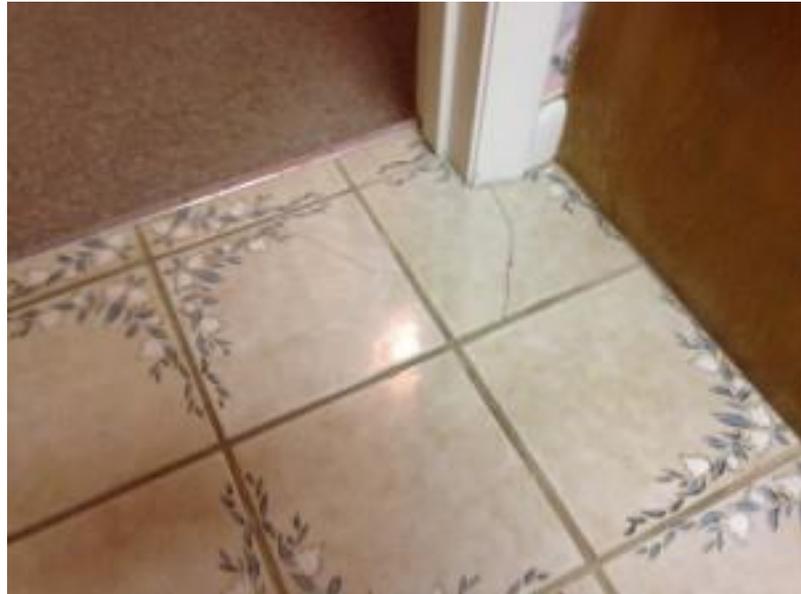
- STAINED CARPET – At various locations.
- DAMAGED / CRACKED FLOOR TILE – At the kitchen.

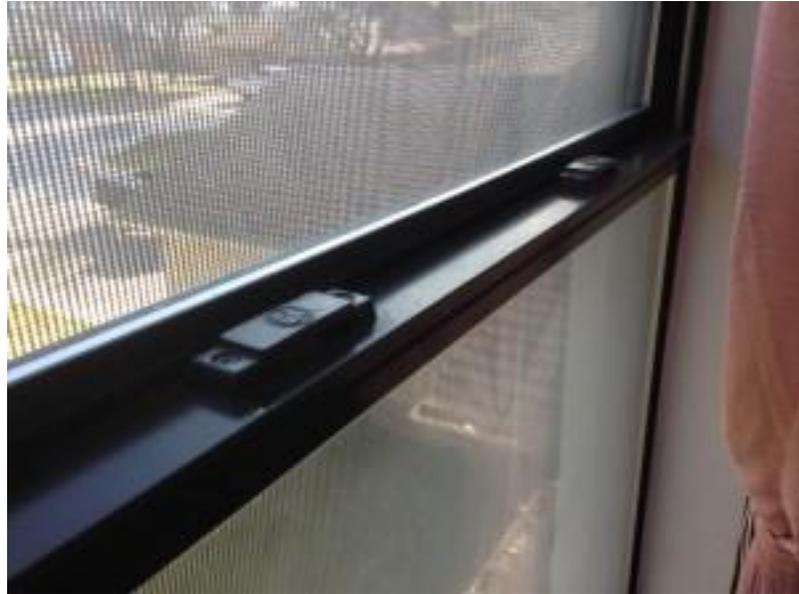
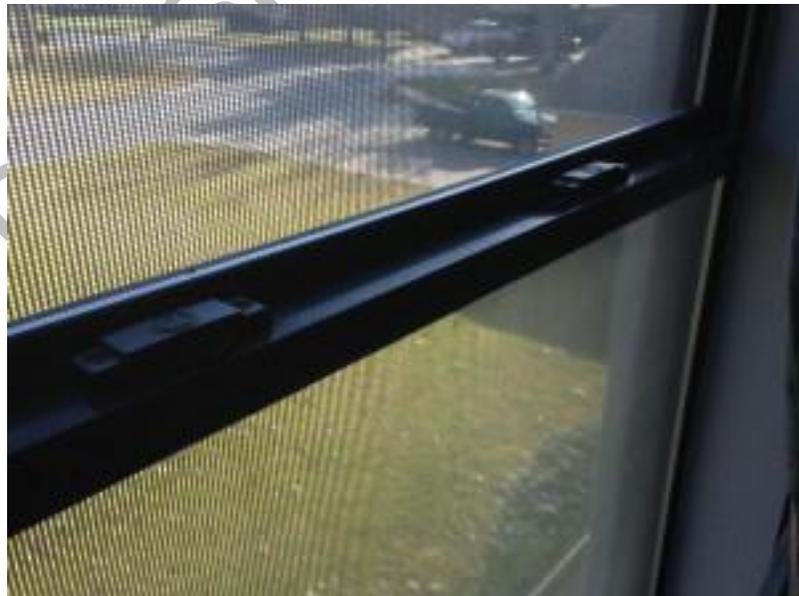
- THE WINDOW LOCKS ARE BROKEN – At the left & right bedrooms.

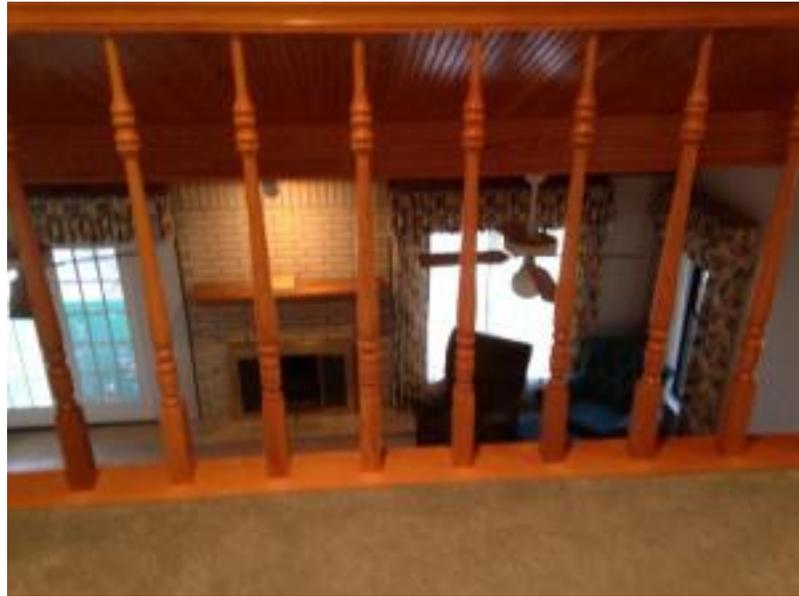
- THE STAIR RAILING & BALCONY PICKETS - Are not 4 in. maximum apart (code change since the house was built from 6in. to 4in.).

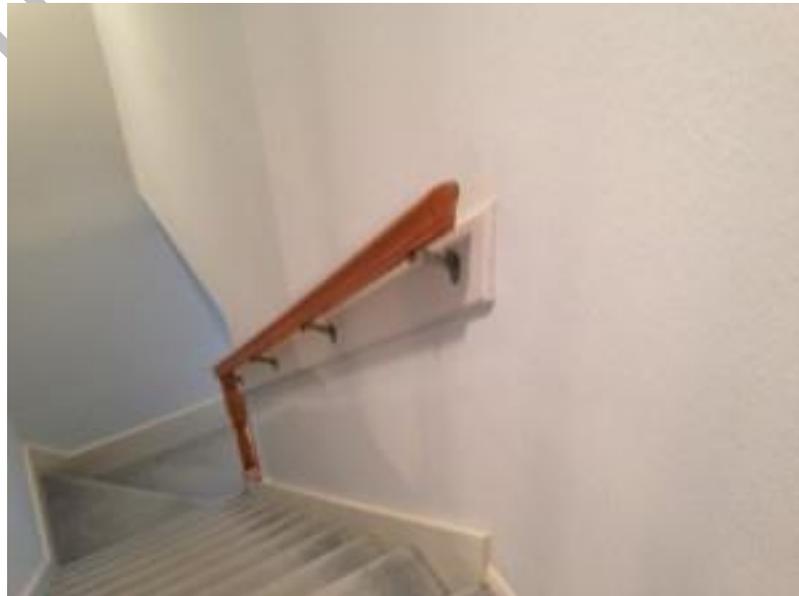
- THE HANDRAIL – The handrail does not turn back to the wall at the top / bottom ends.

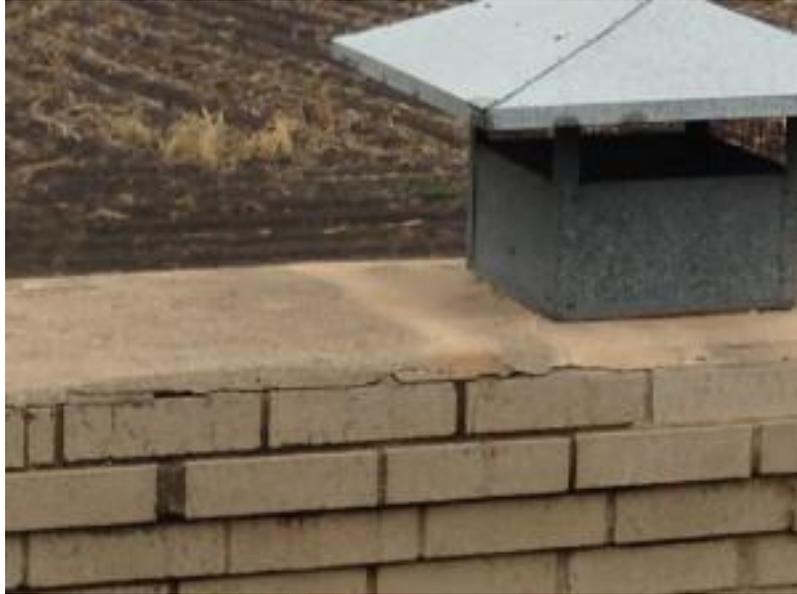
J. Fireplace/Chimney- Comments:
(A smoke test was not performed for chimney draw.)
 ▪ SEAL THE MORTAR CHIMNEY CAP CRACKS.

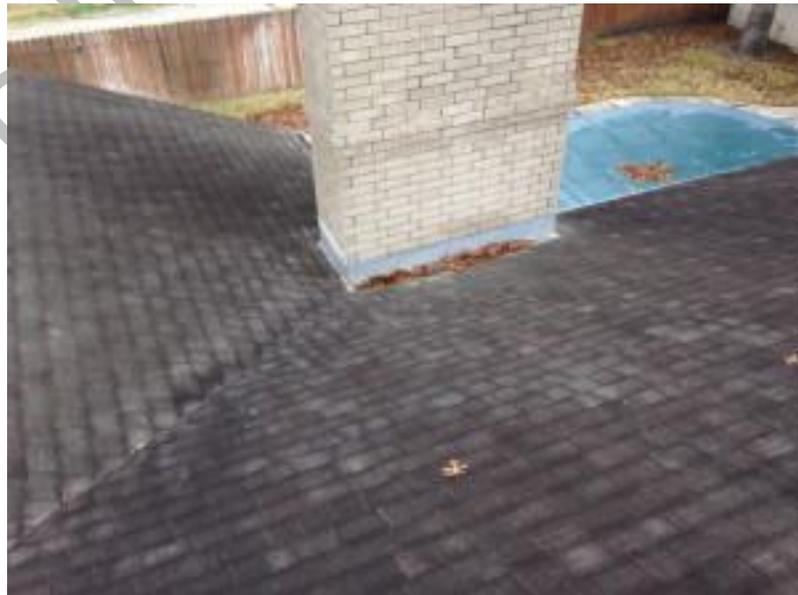
▪ A CRICKET (WATER DIVERTER) - Is missing behind the chimney (required when the chimney width exceeds 30 in.).

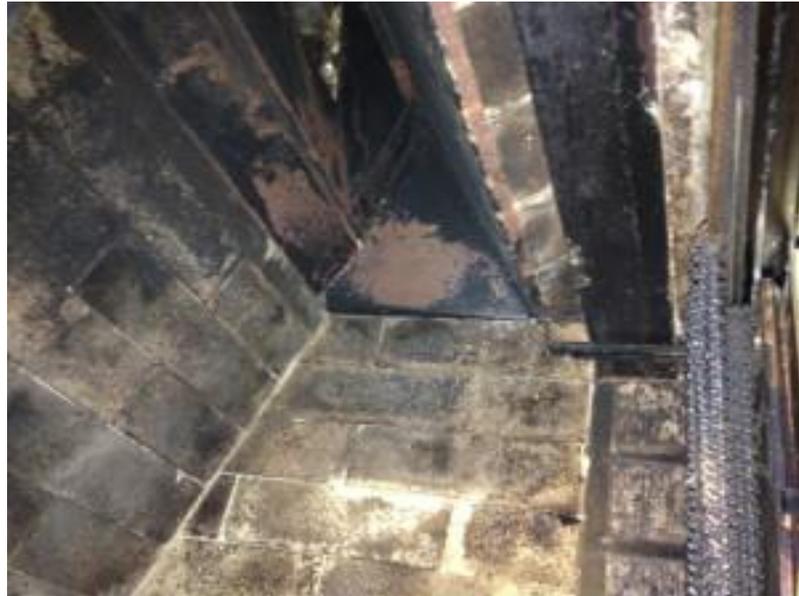
- THE FLUE DAMPER ASSEMBLY - Is rusting.

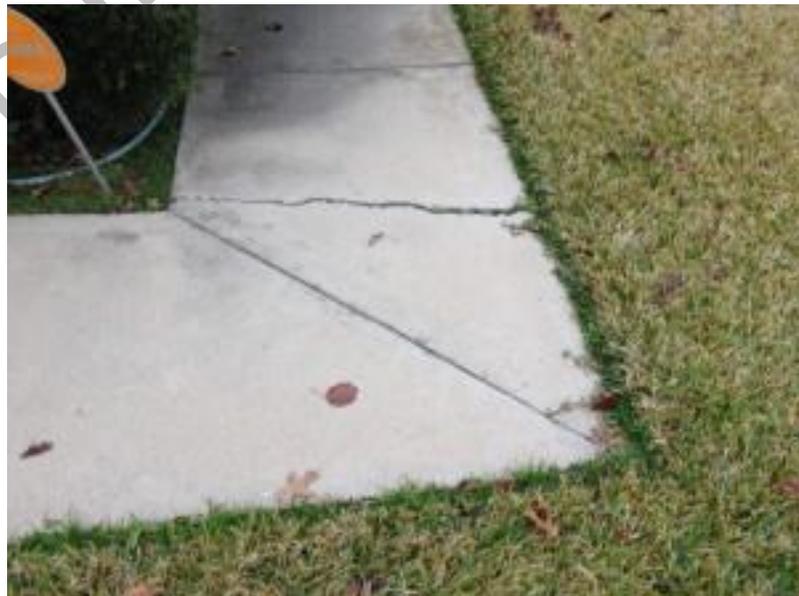
- THE FRONT SIDEWALK – Is uneven / cracked, causing a trip hazard.

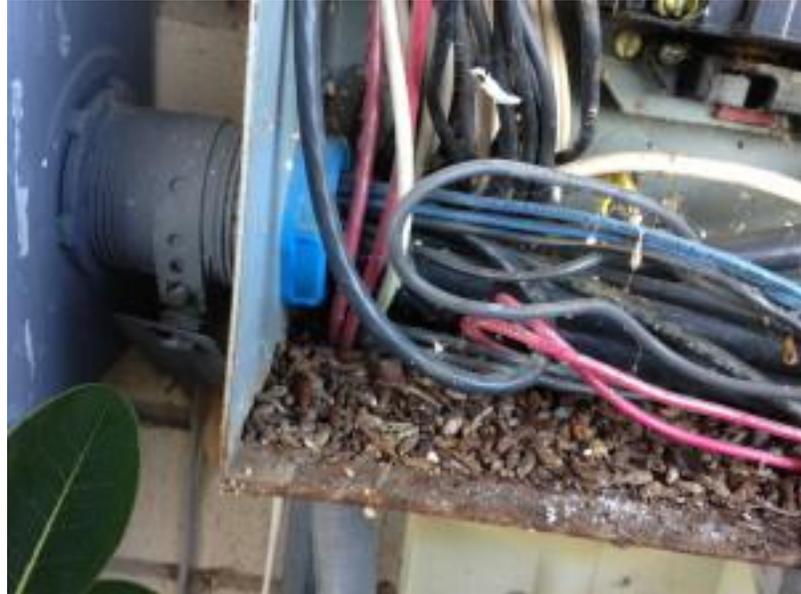
- THE MAIN BREAKER BOX – The gas line is not bonded. The swimming pool equipment is not bonded. The metal water line does not appear to be bonded. Have a licensed electrician evaluate the water line.
- THE LEFT MAIN BREAKER BOX - All the wires pass through one hole in the back of the box, which creates a heat issue. NOTE: Although this wiring method is not in accordance with the code, it is a common construction practice in the Central Texas area. Every house that I have inspected has been wired in this manner.

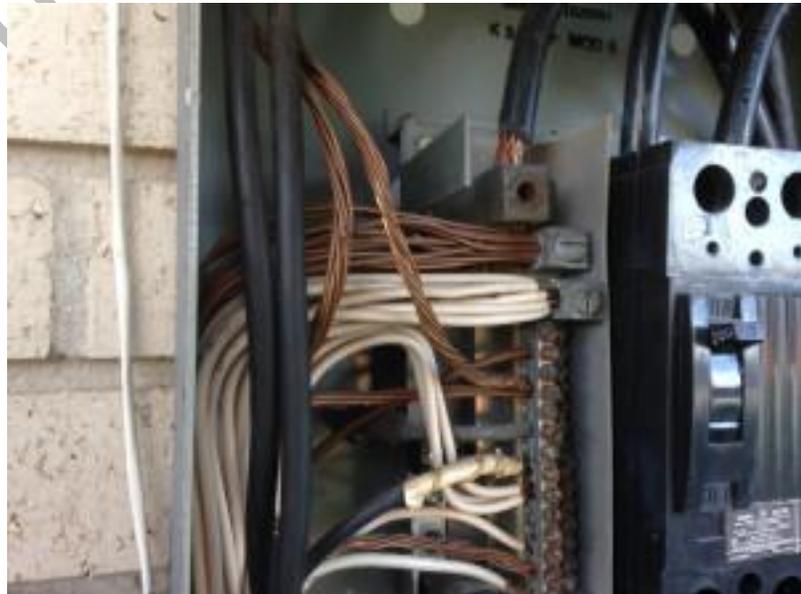
- There are ground wires & neural wires bundled together in 1 lug.

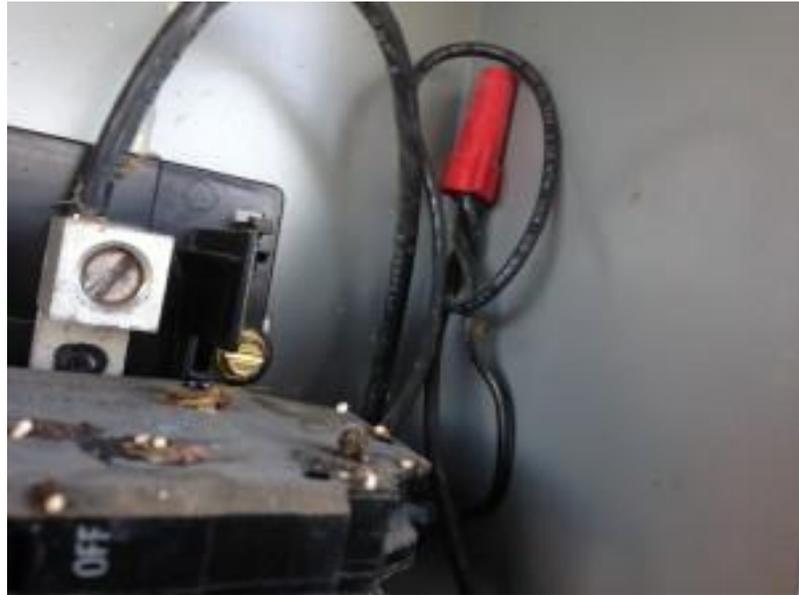
- The front panel screw is pointed rather than flat as required. The sharp screw can penetrate the wire insulation & cause a fire hazard.
- THE RIGHT MAIN BREAKER BOX - The box has 1 double lugged wire nut, add 1 breaker & separate the 2 wires in the double lugged wire nut to 1 wire per breaker.

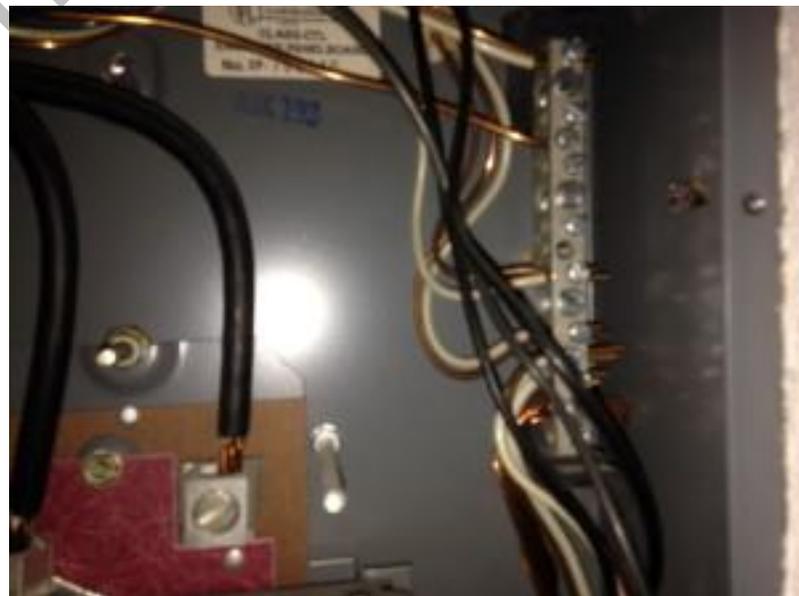
- THE SECONDARY BREAKER BOX – The box is not bonded.
- There are ground & neutral wires installed together under the same screws, which is a fire hazard.
- The ground & neutral wires are not separated to ground & neutral buss bars.

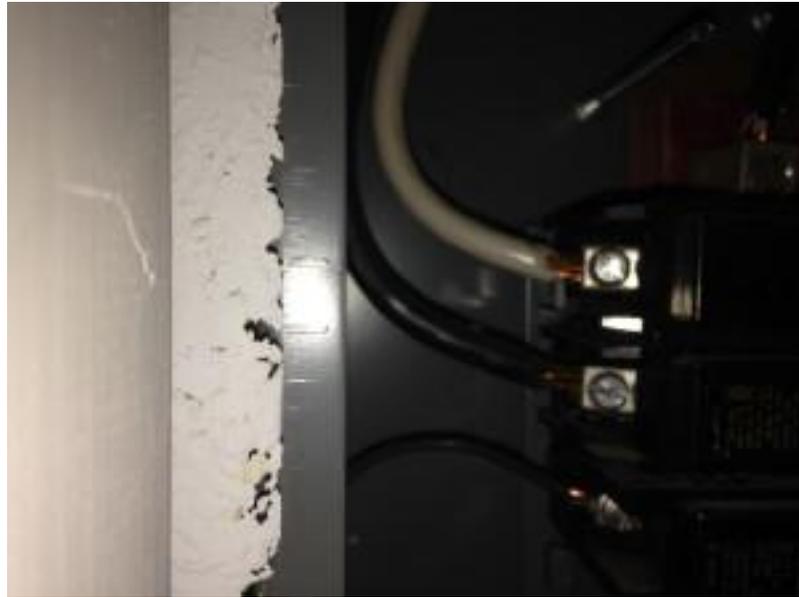
- There is exposed wire at the connections to the breakers at various locations. The insulation has been cut too short.

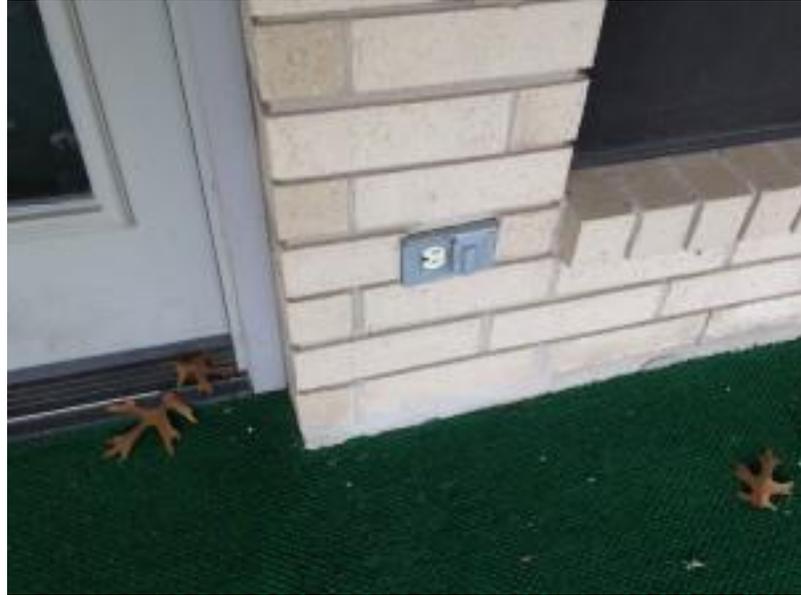
- THE WEATHER PROOF OUTLET COVERS AT THE EXTERIOR OUTLETS –
Are damaged at the rear porch & the right front.

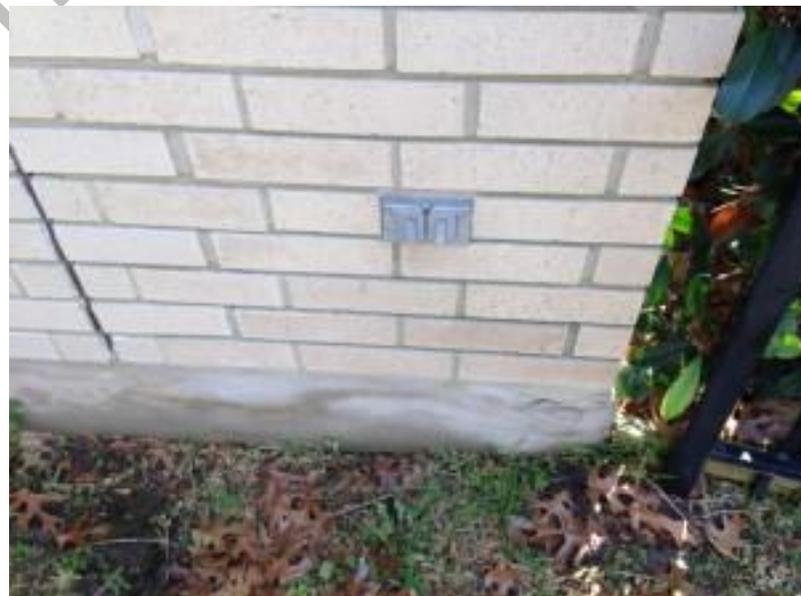
- The covers are not the “bubble type covers” required for “wet locations” (where there is not a roof protecting the outlets) at the right front & at the AC condensing unit.

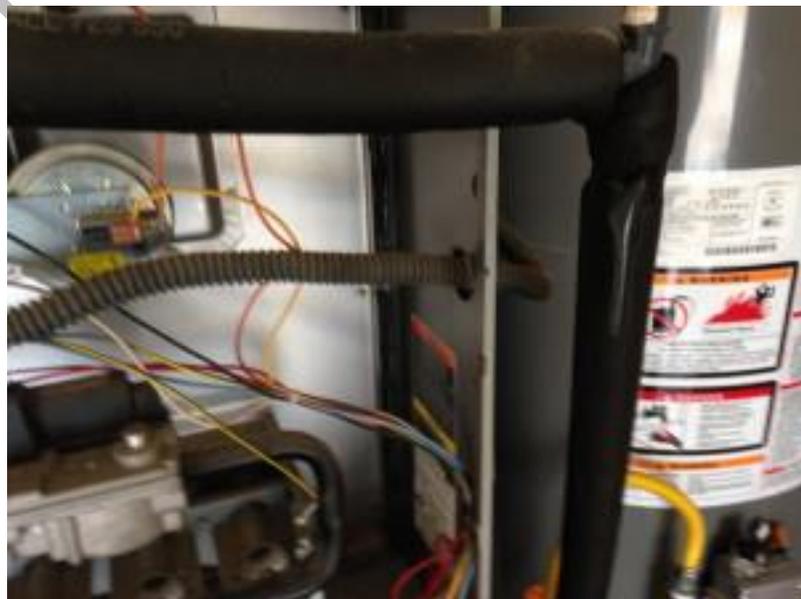
- THE FLEX GAS SUPPLY LINE – Is improperly installed. The line is not allowed to pass through the housing of the furnace unit. Add rigid black pipe from the control box through the housing & connect the flex line to the black pipe outside the housing.
- THE GAS LINE – Is missing a drip leg / sediment trap.

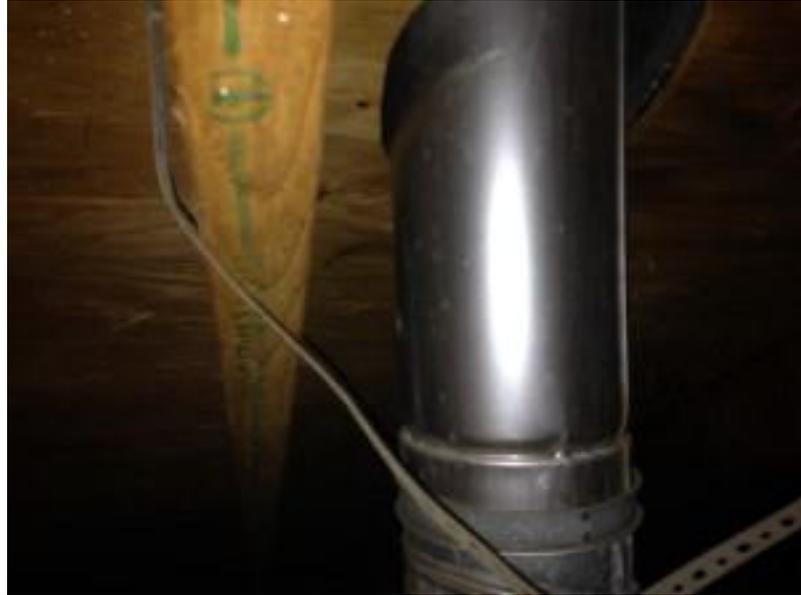
- THE VENT PIPE – Does not have a 1 inch minimum clearance from combustible materials at the roof decking, which is a fire hazard.
