PROPERTY INSPECTION REPORT

Concerning: Sample House Built in the '80s Insp.#: 150129- A
(Address or Other Identification of Inspected Property)

By: Danny Pitts, TREC License # 4717 1/29/15
(Name and License Number of Inspector) (Date)

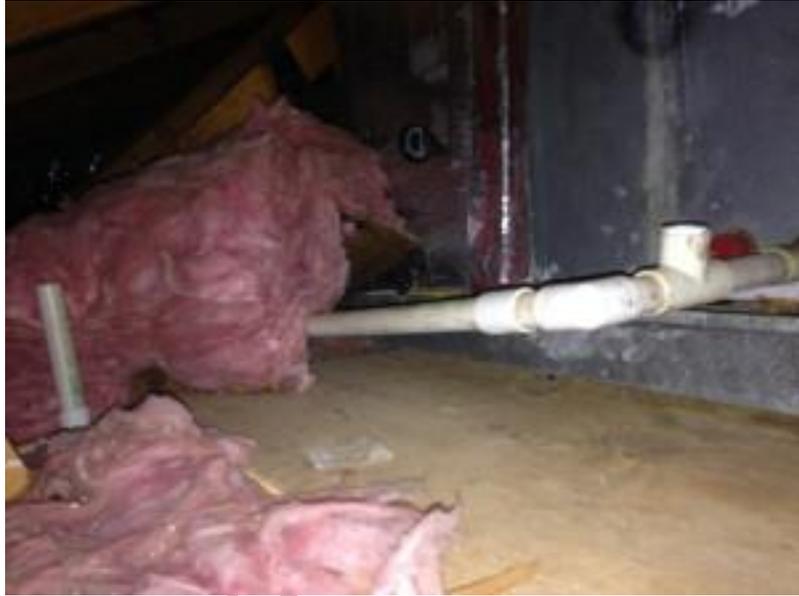
- THE CONDENSATE DRAIN LINES - The entire drain line of the upstairs unit is not insulated in the attic (required as of the 2000 code). A P-trap is missing in the line.

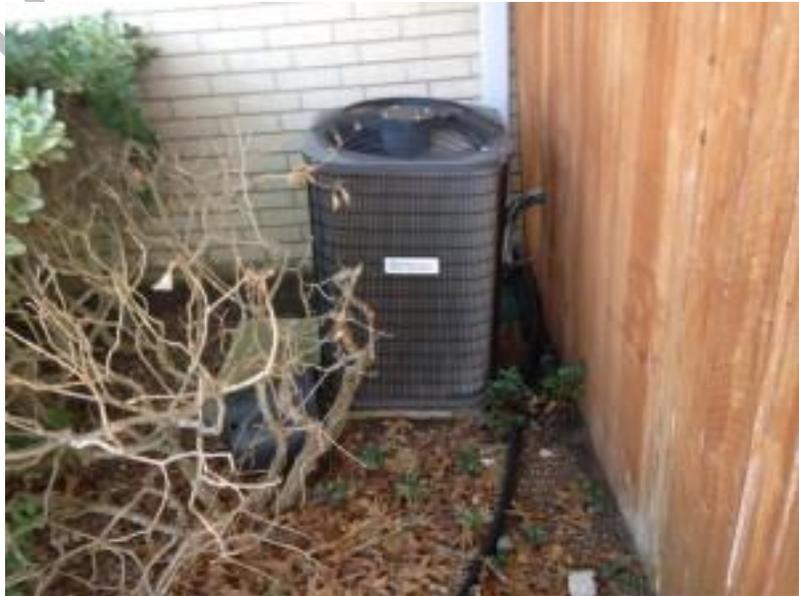
- Did not locate the termination of the downstairs line, is possibly buried.
- THE CONDENSING UNITS – The right unit is not level.

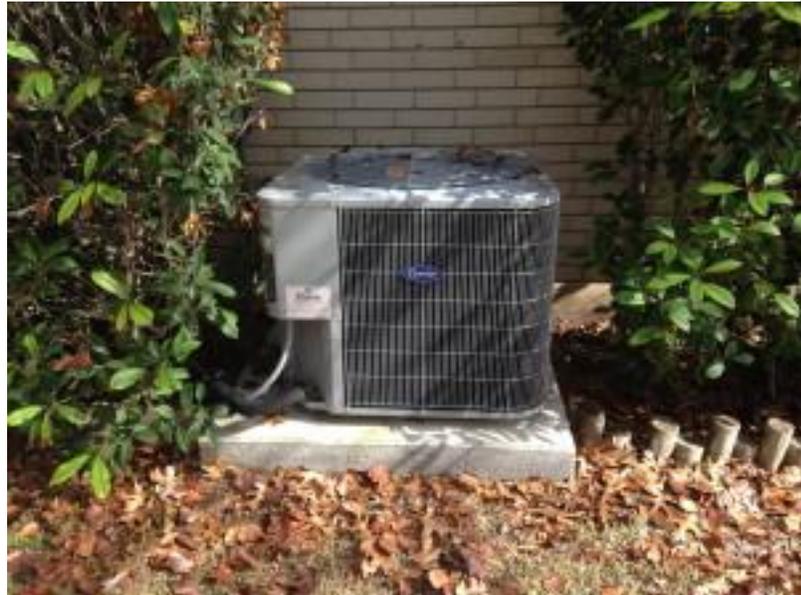
- The left unit has an undersized breaker in the breaker box (30 amps). The manufacturer specifies a 40 amp maximum breaker be provided. Many electrical engineers recommend that the maximum size breaker allowed should be installed for optimal performance. Air flow for the left unit is obstructed by the shrubs around the unit.

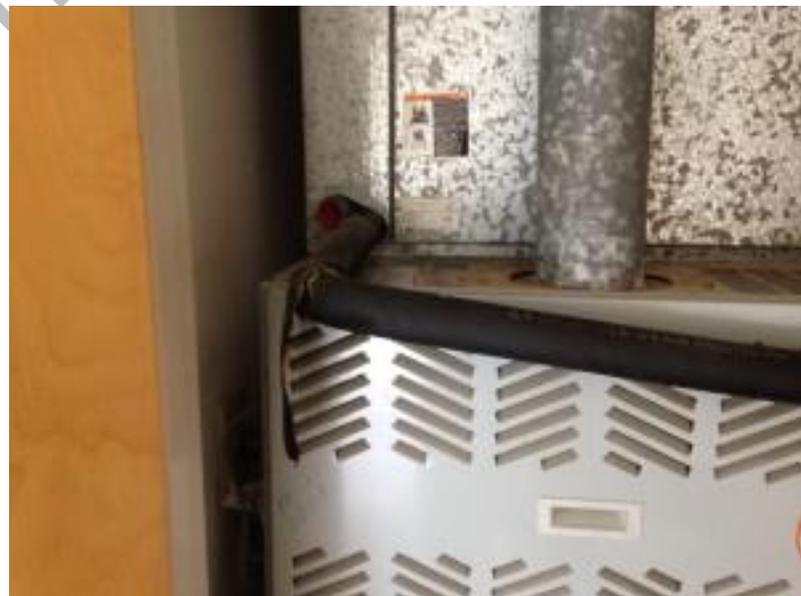
- A SECONDARY OVER FLOW PAN WITH A DRAIN LINE TO THE EXTERIOR OR A FLOAT SWITCH - Is missing at the downstairs unit. Flood protection is required for all types of AC systems installed inside of the house (required as of the 2000 code). Add a float switch to upright units.

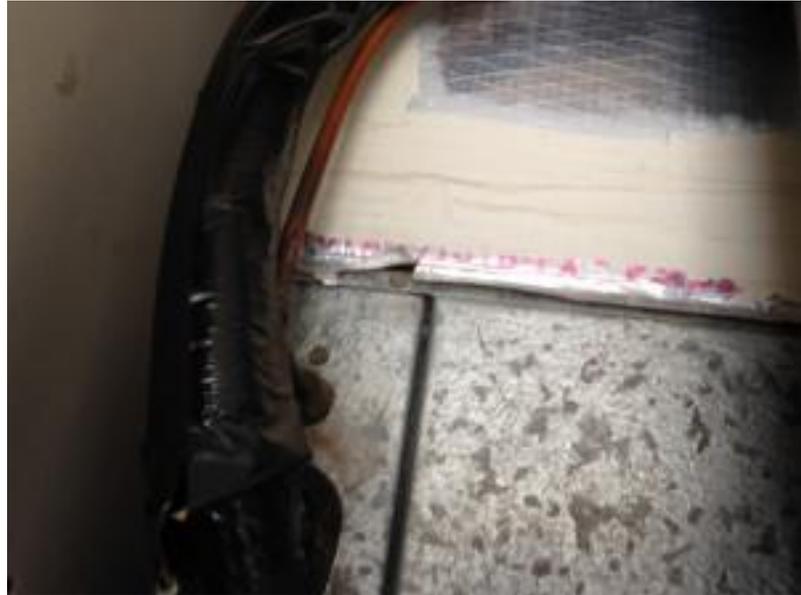
- THE DUCTS – Were inaccessible & were not inspected.
- RE-TAPE THE DOWNSTAIRS PLENUM - With proper foil tape, not duct tape.
Seal all the air holes at the closet plenum.

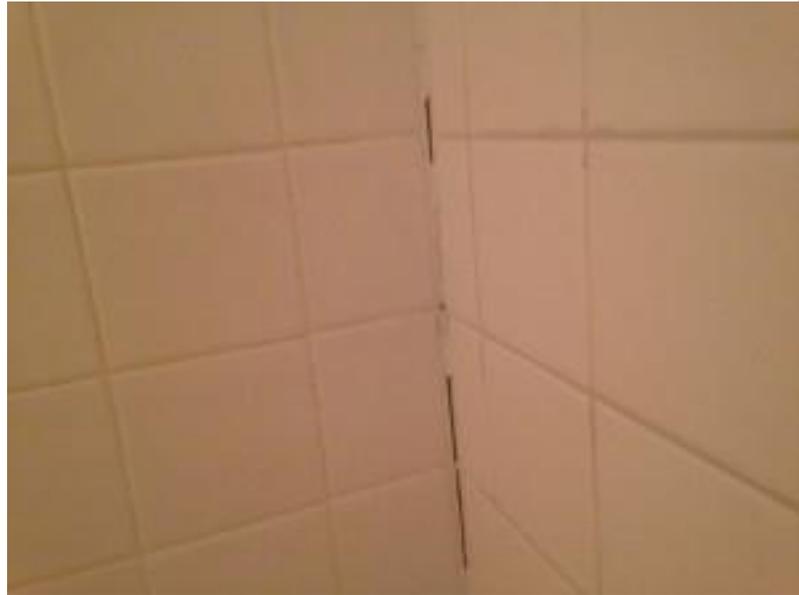
- THE TOILETS ARE NOT FLUSHING PROPERLY – At the hall bath & the shared bath.
- REGROUT THE CRACKS IN THE TILE GROUT – At the tub / shower in the hall bath & the shared bath.

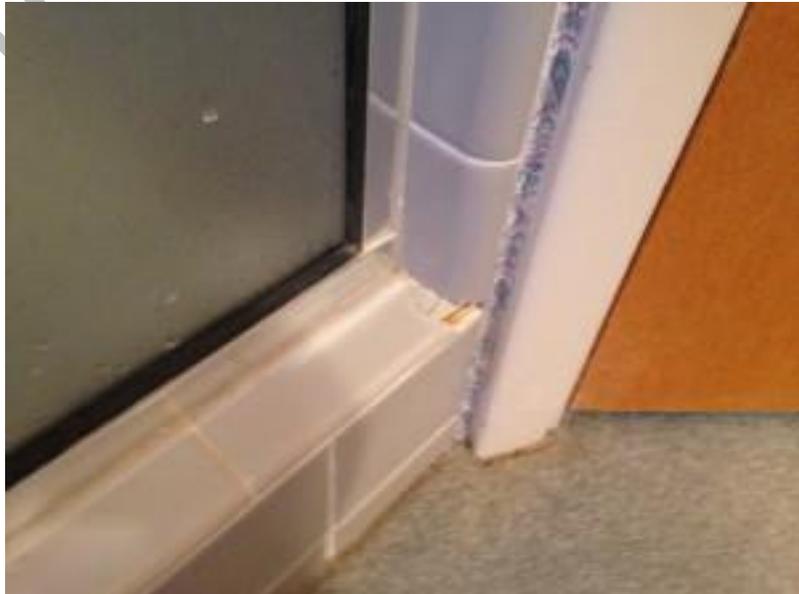
- THERE IS BROKEN / LOOSE TILE – At the master bath shower.

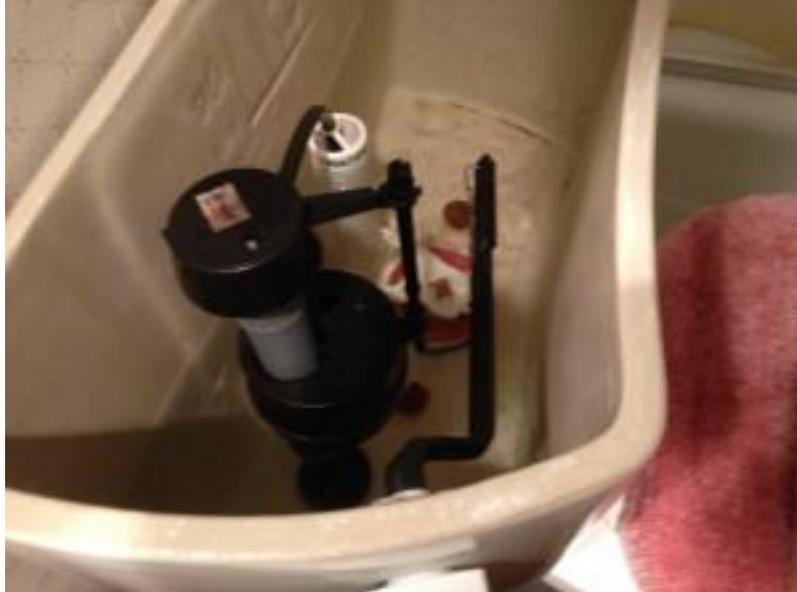
- THE TOILET TANK BOLTS – Are rusting at the hall bath / the ½ bath.

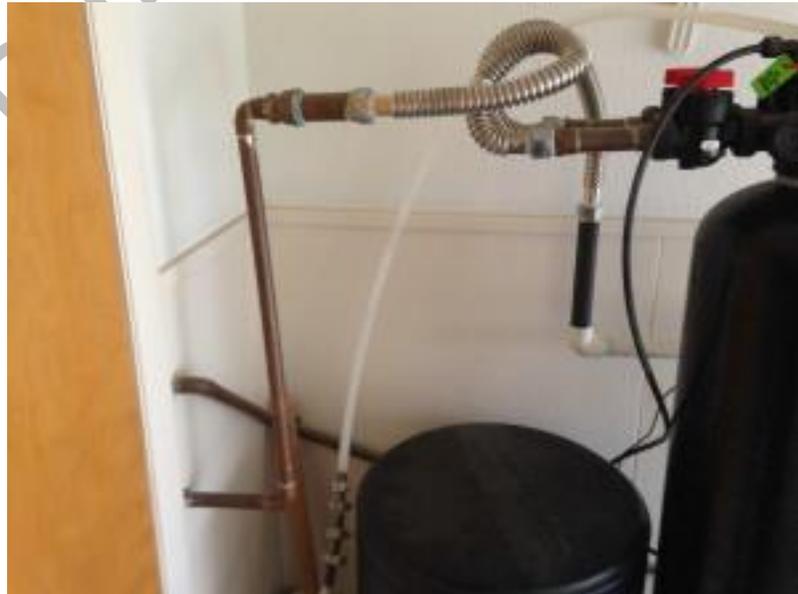
- THE PIPES - Are not insulated at various locations in the garage & at the water heater.

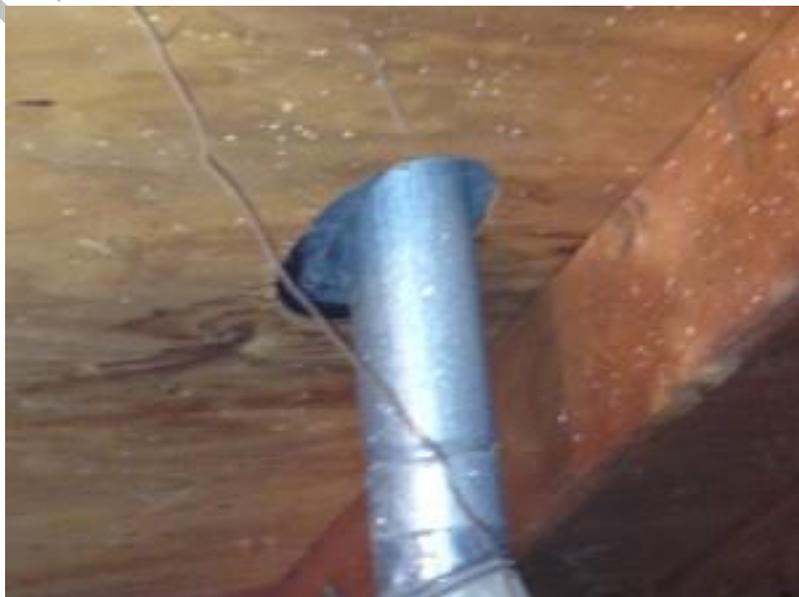
- THE VENT PIPE – Does not have a 1 in. minimum clearance from combustible materials at the roof decking, which is a fire hazard.

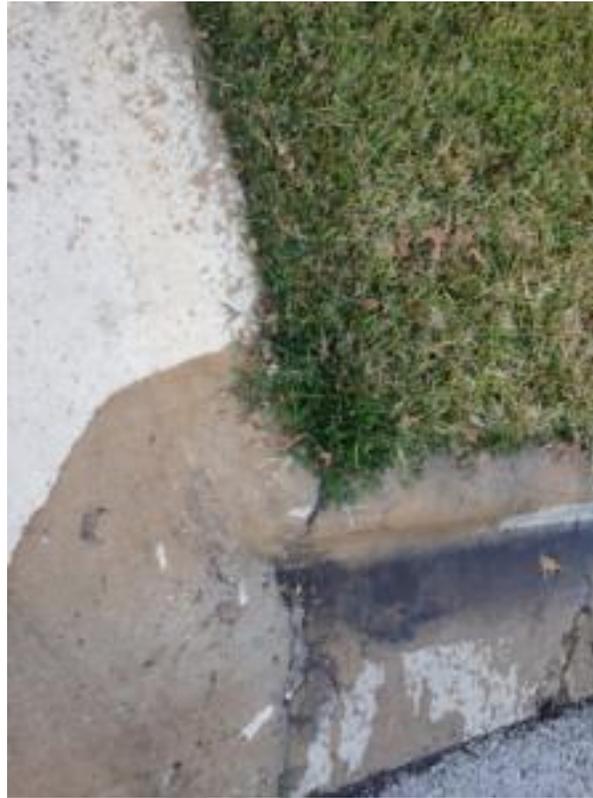
- STATION # 3: 1 Head is broken.

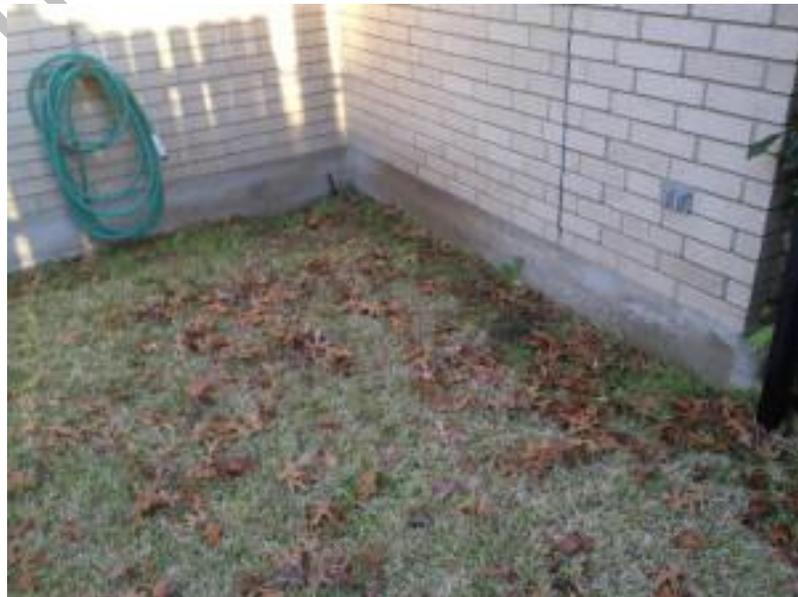
- ADJUST THE SPRINKLER HEADS – At various locations. The heads are spraying against the house at station # 10.

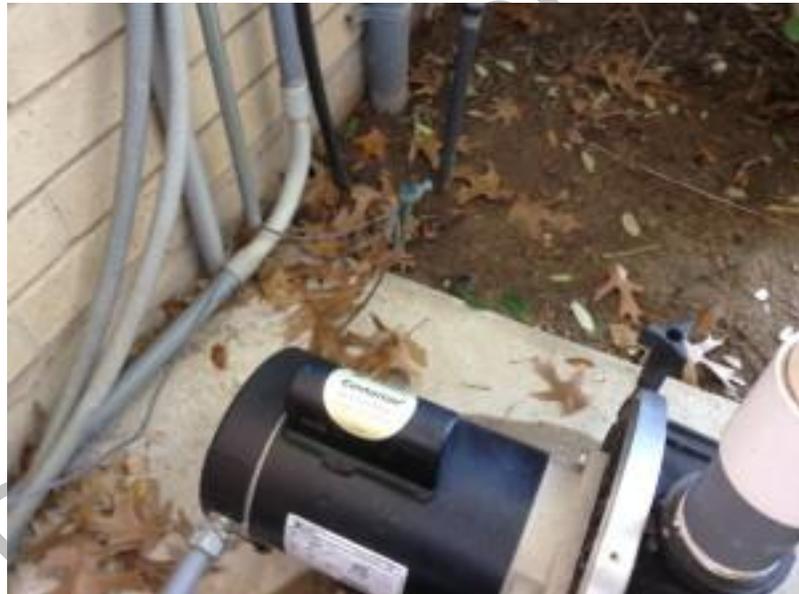
- THE MOTOR – The motor & other equipment are not bonded as required. Rather a ground wire was observed. Transfer the "ground wires" to the main breaker box to bond the equipment.

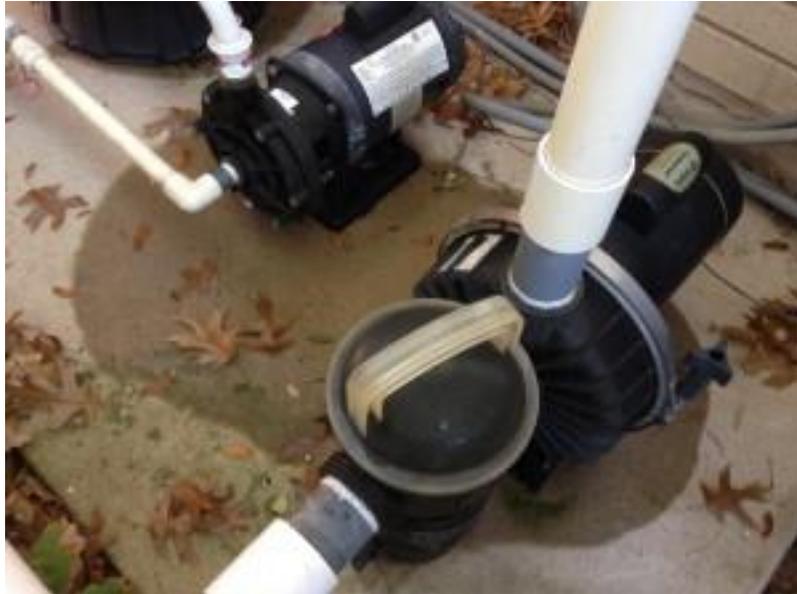
- THERE ARE WATER LEAKS – At the pool equipment.

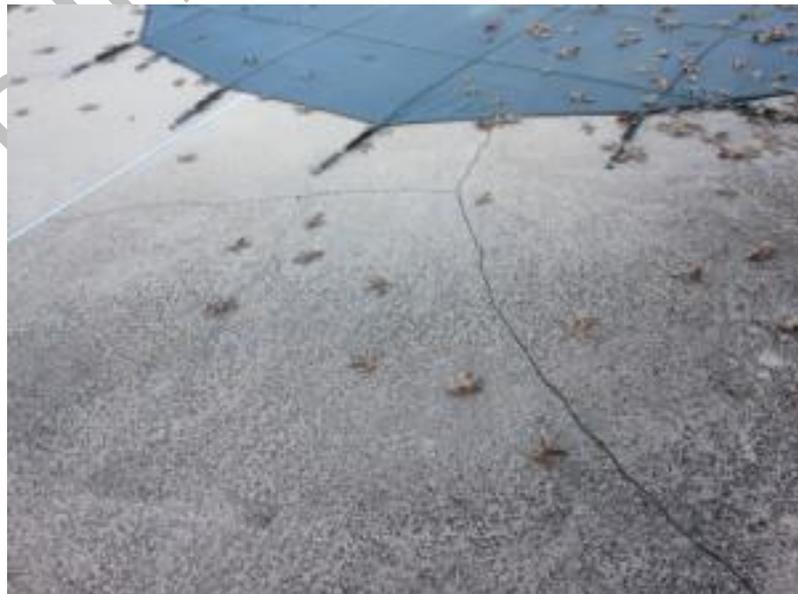
- THE DECK AROUND THE POOL – Is damaged / cracked at various locations.
